TECHNICAL REPORT ARCCB-TR-92033

**FAILURE ANALYSES OF
M3A1 BASEPLATE FOR 81-MM MORTAR 252**

STEVE TAUSCHER

JULY 1992

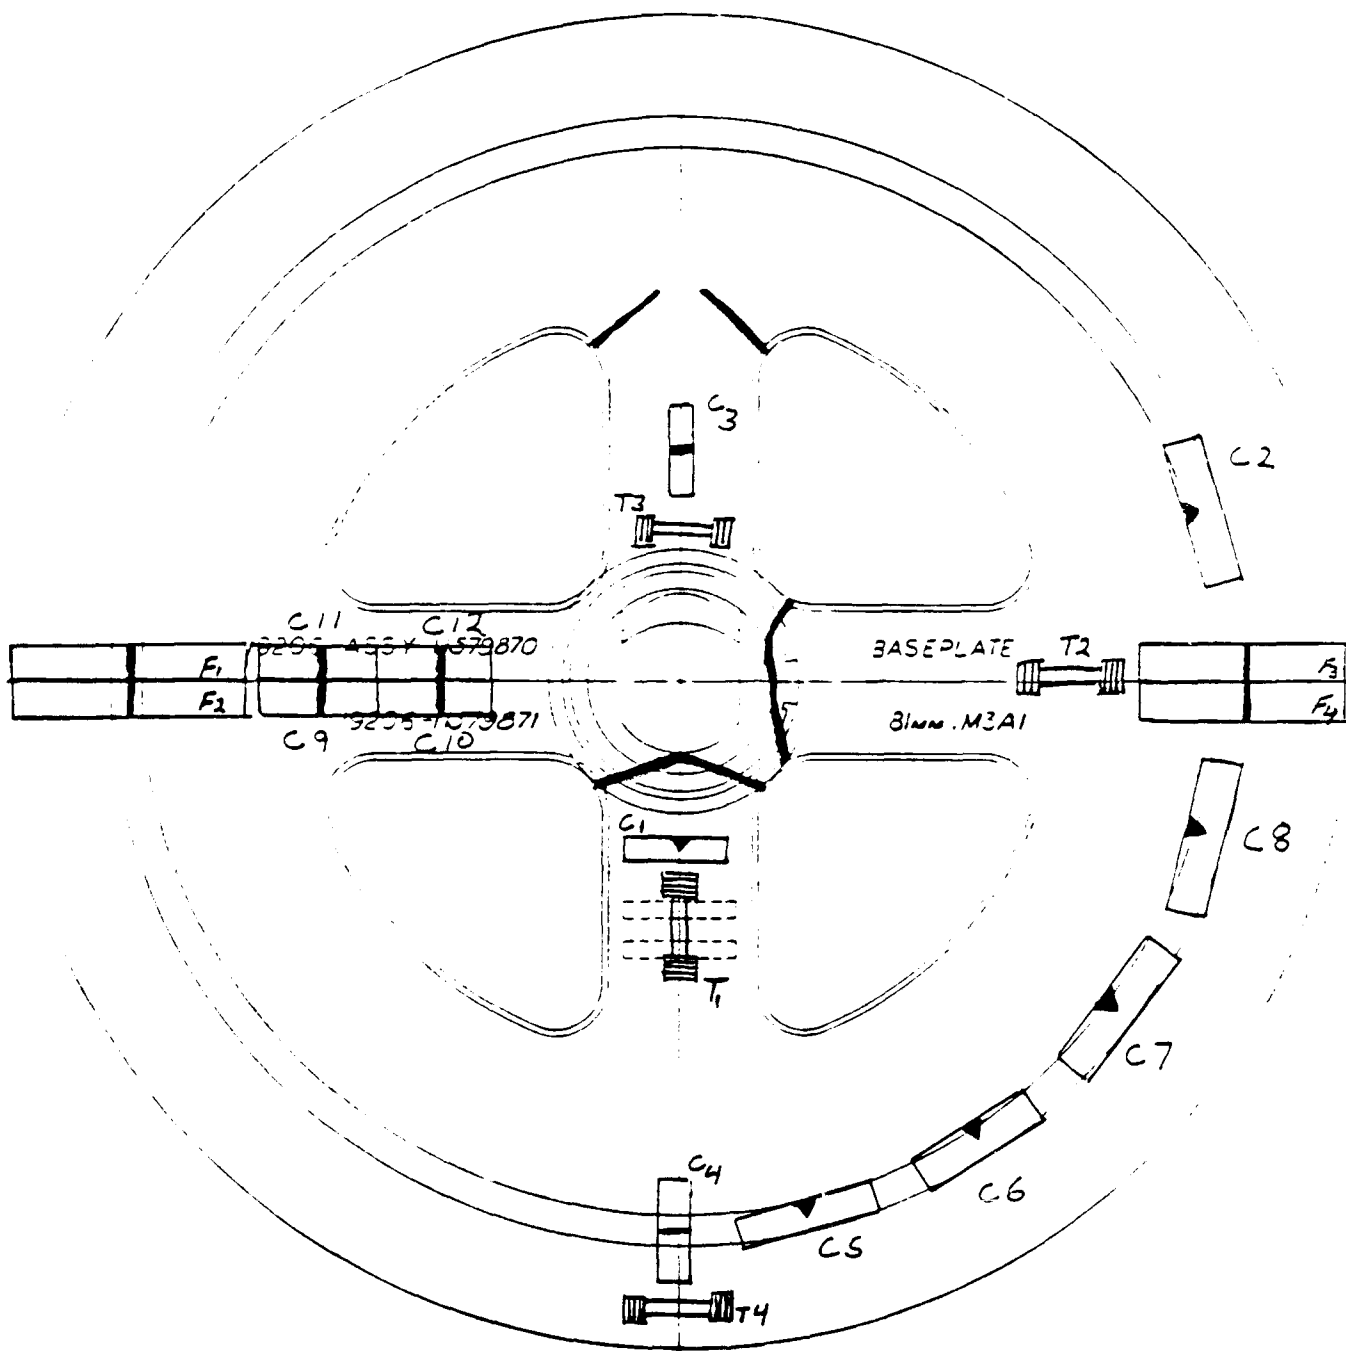
Figure 20. Schematic of mechanical property specimen section.

Mechanical property testing was conducted to verify that the baseplate met the requirements of Specification QQ-A-367H and that low mechanical properties did not contribute to the failure. Hardness, tensile, Charpy impact toughness, and fracture toughness specimens were taken from the baseplate at the locations and orientations shown in Figure 20. The grain flow pattern, as revealed by metallography, was used to sample for tensile properties parallel and perpendicular to the grain flow as specified in paragraph 4.2.3.1 of QQ-A-367H. Tensile, Charpy impact, and fracture toughness tests were conducted according to ASTM Methods E-8, E-23, and E-399, respectively. The properties are summarized in Table III and are representative of the fine-grained microstructures revealed through metallography. In all cases, the properties exceeded specified properties. Fracture toughness in this baseplate, which is not specified, was typical of that in 2014-T6 aluminum (ref 4). In summary, the mechanical properties in this baseplate are indicative of 2014-T6 alloy that has been properly melted and processed.
